16-Bit MCU with 512K Byte FLASH and 18K Byte RAM Memories

ERRATA SHEET

This errata sheet describes the functional and electrical problems known in the revision AB of the ST10F280-AB engineering samples.

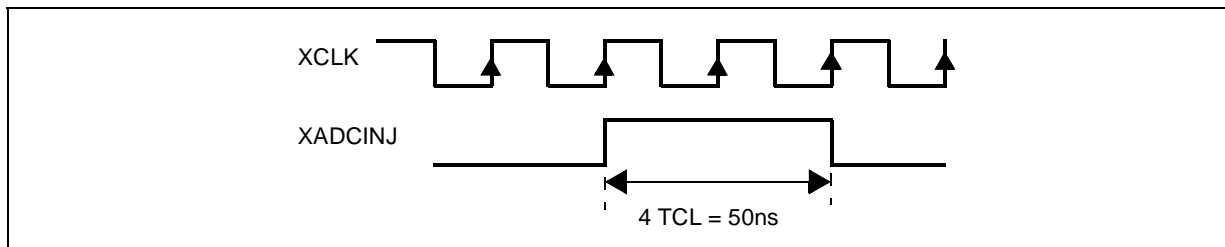
Figure 1 : XADCINJ Timing

2.4 - ST_XTIMER.01 - XADCINJ Signal Output Too Short for ADC Channel Injection

The duration of the XADCINJ output lasts two cycles (50ns at 40MHz) but to ensure that a signal transition is properly recognized, an external capture input signal should be held for at least 8 CPU clock cycles before it changes its level so the duration of the XADCINJ signal is too short.

Workaround:

The falling edge of the XADCINJ signal must be delayed up to 8 CPU clock cycles.
